超声波美容换能器
(Ultrasonic Beauty Transducer)

HNM-4SS-3528-D62D

产品规格书

Specification

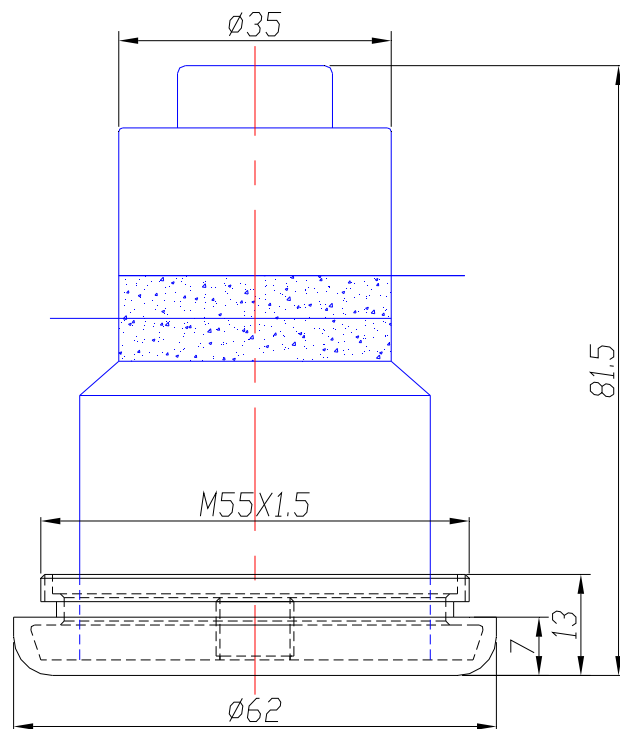
10. 外形示意图 (Drawings and Dimension)

详见产品外形图 As per the drawing No:

HN131010-02D 3/3 (HNM-4SS-3528-D62D)

7.1 前辐射块 Front matching: 铝合金 (Aluminum Alloy)

7.2 后匹配块 Back matching : 合金钢 (Steel Alloy)

7.3 压电晶体 Piezo-ceramic: PZT-4 (PZT-4)

7.4 电极片(Electrode): 磷青铜 (Copper Alloy)

7.5 振动帽 (Vibration Cap): 不锈钢 (Stainless steel)
